## A CASE HISTORY

**Project:**  
Rembrandt Terrace  
Dallas, TX

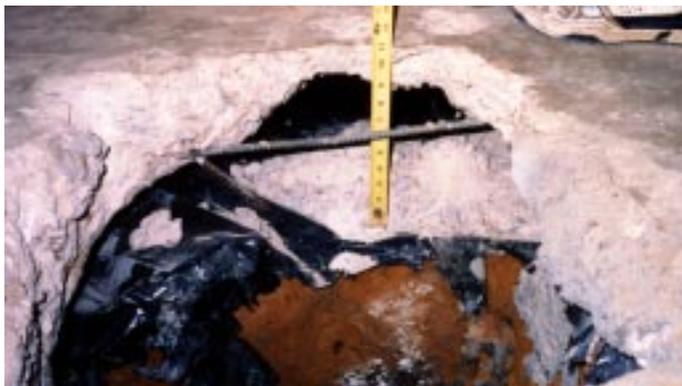
It was decided to use the Chance HELICAL PIER<sup>®</sup> Foundation Systems anchors on the interior grade beam. A 10" helix on a 7' shaft was installed using extension material to a depth of 20' to attain a bearing capacity of 25 Kips. The shaft of the anchor would then be encased by a sonotube with a foot-bracket encased in high strength concrete. This would provide the lift platform to use to raise the interior of the home in conjunction with the lift on the exterior grade beam. The lift was effected to 9" as indicated in the bottom photo.
