CASE STUDY

Project: Huber Home West Vancouver, B.C.	Structural Engineer: Somerset Engineering Burnaby, B.C.	Geotechnical Engineer: Geopacific Consultants Burnaby, B.C.	Contractor: Vickars Construction Burnaby, B.C.
--	--	--	--

Project description:

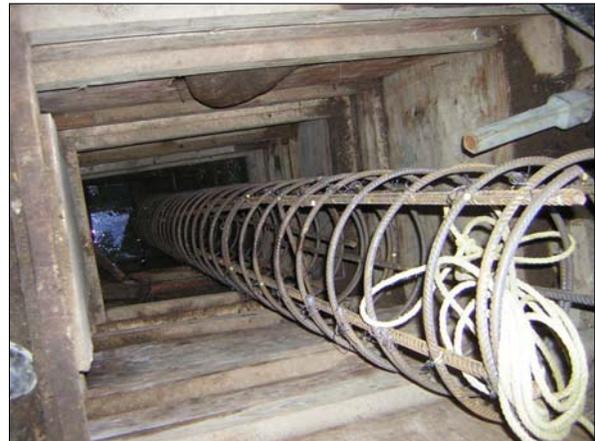
35 year old wood post and beam constructed home founded on a mixture of spread footings, cantilevered grade beams and grade slabs on a bench formed on a steeply sloping lot. The bench was created by filling over rock outcroppings near the edge of a steep ravine. The house was exhibiting differential settlement of the adjoining garage and house over. The grade beam supports were failing along with the spread footings on the ravine side of the structure due to downhill movement along with some consolidation of the underlying fill on the rock slope.

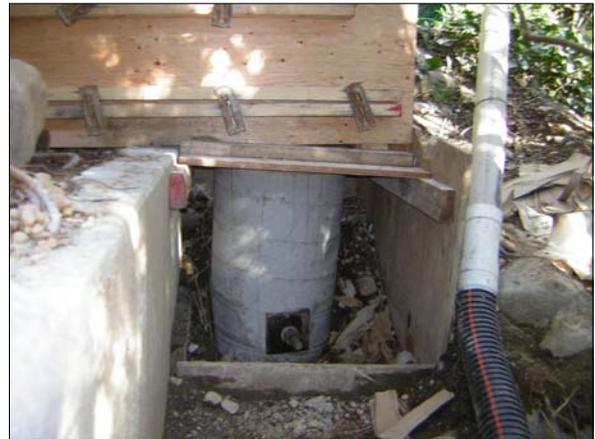
Variable sandy fills were encountered beneath the length of the involved foundation sections. At the north end soft sandy fill overlay granite bedrock between 5-8 feet in depth. The southern half of the foundation was found to be underlain by sandy fill to 8-10 foot depth, followed by increasingly dense sands with gravel. No rock was encountered in underpinning pits extending between 11-16 feet deep over the southern half of the building foundation elements.

In view of the demonstrated downhill movement of the fill layers beneath the involved foundation elements an underpinning repair was instituted utilizing hand dug, shored pits extending either to rock or stable underlying dense sands and gravels. Reinforced concrete footings were placed on the gravel and reinforced concrete columns were brought up supporting new structural grade beams attached to the existing

foundations. The grade beam also extended under the cantilevered (existing) grade beams supporting the garage portion of the structure with the house over.

In those pits where rock was encountered reinforcing steel was dowelled into the underlying granite to resist overturning forces generated by the horizontally moving upper fill layers. The remainder had horizontally placed helical tension anchors placed into the upper column sections to resist the overturning.

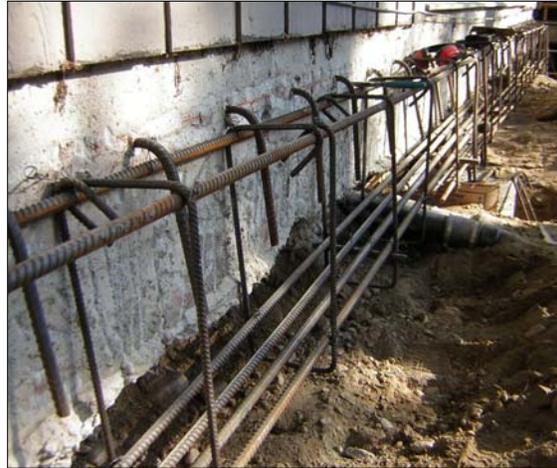
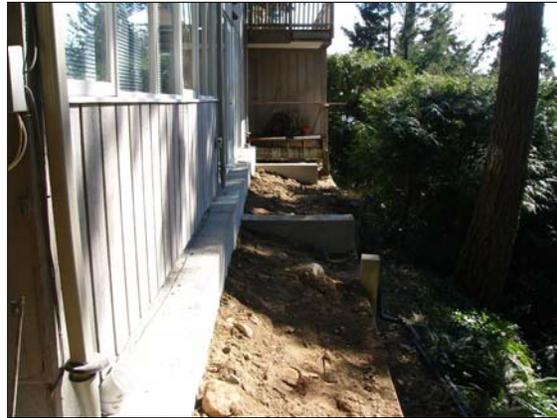
Previous repairs to the home consisting of hydraulically placed pipe piles had failed due to ground movement with bending of the shafts and tearing of attachments to the existing cantilevered beams of the home.

Horizontal projections towards the ravine were cast in a monolithic fashion with the underpinning assemblies and the support grade beam allowing construction of a wood sundeck off the ravine side of the home. The whole structure thereby stabilized at depth on competent soils with no elements of the home relying on the moving fills.

Unlike that repair, the completed job done by Vickars Construction, under the direction and auspices of competent engineering consultants, comes complete with a 20 year transferable warranty. Another Vickars repaired foundation assembly, replacing the equity lost in the home, by an unfortunate series of circumstances befalling the homeowner.
