CASE STUDY

Project: Hudson House Saannich, B.C.	Structural Engineer: Somerset Engineering, Burnaby, B.C.	Geotechnical Engineer: Geopacific Consultants Burnaby, B.C.	Contractor: Vickars Construction Burnaby, B.C.
---	---	--	--

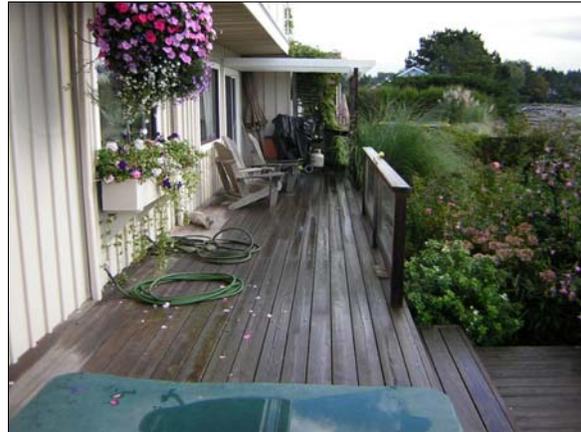
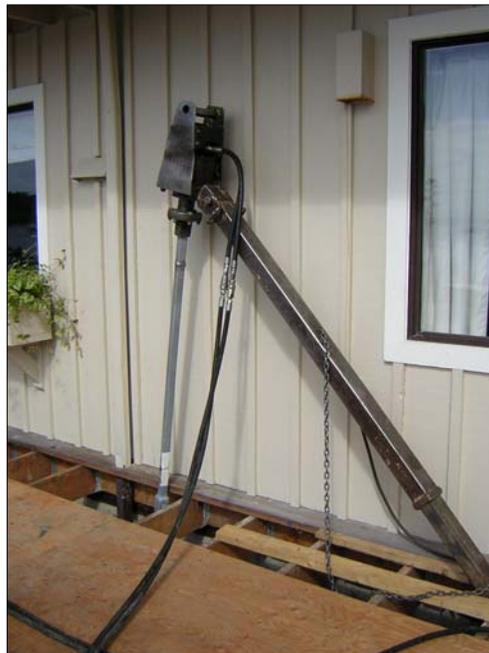
Independent materials investigation complete with testing, found degradation of the variably untreated wooden pilings of the home, some with crushing and failure of support of a main section of the living room and guest room. This was noted as changes in the fit and finish of the master bedroom of the second floor and the living room of the main floor. Drywall cracks at post support areas and binding of doors in the two areas was evident. Direct differential settlement was measured at more than 2" in 20' in the involved sections of the home.

Due to the high water table and proximity to the ocean it was elected to simply replace the degraded wooden pilings with HELICAL

PULLDOWN™ Micropiles. This allowed use of hand held piling rig capable of placing pilings of ultimate capacities of 70+ Kips (315kN), including three inside the four foot high crawlspace. A series of reinforced concrete grade beams coursing across the crawlspace allowed direct connection of the pilings to the existing concrete foundations as well as elevation of settled foundation section re-approximating the structure to its post construction “as built” levels, during the repairs. This also allowed preservation of existing hard and soft landscaping as pilings were also placed through removed sections of Cedar decking and garden areas, easily replaced to pre-repair finish without extra costs or damage.
