A CASE HISTORY

Talbot School
Billerica, MA

Veitas & Veitas
Braintree, MA

Jager Construction
Amherst, NH

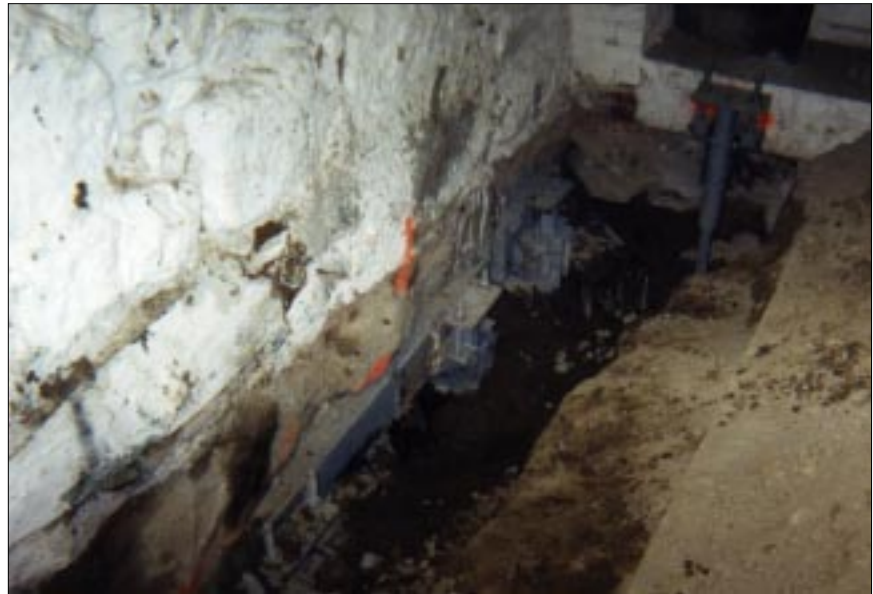
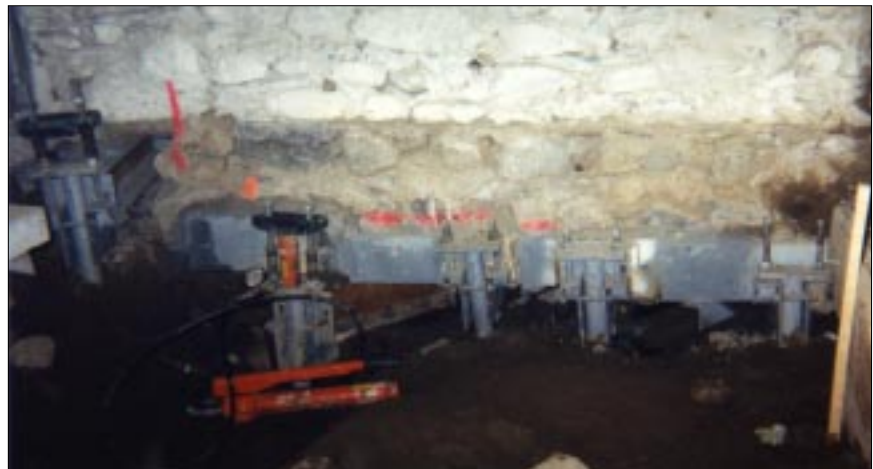
During construction of the elevator, the wall was totally undermined and all its weight was supported by the HELICAL PIER Foundation Systems anchors.

To prevent the wall from collapsing, HELICAL PIER[®] Foundation Systems anchors were used to support the interior wall during and after construction of the elevator. Five anchors also were used on an adjacent exterior wall to prevent lateral movement from soil pressure pushing in on the wall after the existing concrete slab and soil were removed.

Each anchor was installed to a minimum of 2,500 ft.-lb. for a bearing capacity of 25,000 pounds. 8" x 8" angles were fixed on top of the foundation repair brackets above each anchor and set under the wall, with high-strength grout filling the voids. This was done on both sides of the wall.
