CASE STUDY

Project: Carrington Estates Richmond, B.C.	Geotechnical Engineer: Levelton and Associates Richmond, B.C.	Structural Engineer: Bogdonov Pao & Associates. Vancouver, B.C.	Contractor: Vickars Construction Burnaby, B.C.
---	--	---	--

Job Description:

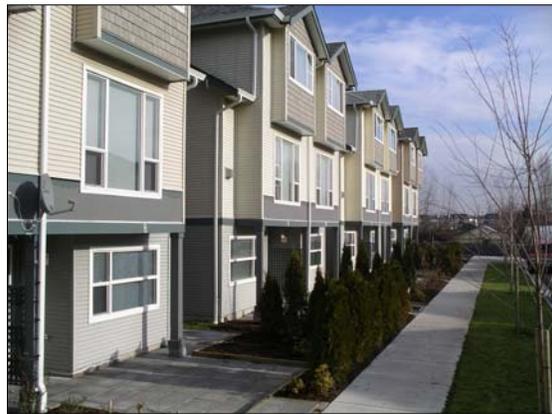
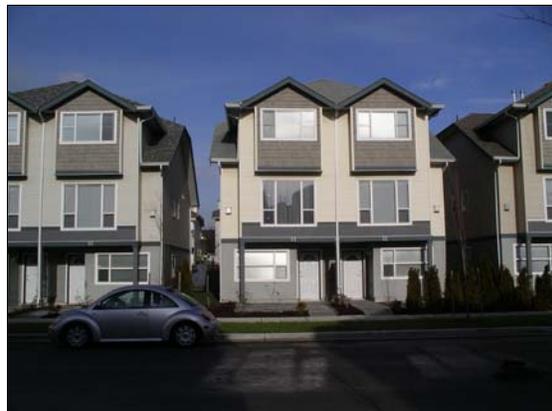
After construction of these four townhouse double units, settling became apparent and had progressed to an astounding differential movement of 13 " across two of the units. The other two units were 11 and 8 inches differentially settled.

As the underlying cause of this massive settlement was thought to be the dense layer of fills settling into the soft silts any remedial piling driven through this area would feel large down drag forces known as negative skin friction. That and the predictable shearing of services to the buildings at the piled foundations by the settling soil mass made such a repair option undesirable. Therefore Vickars proposed to the structural and geotechnical engineers the alternative of shallow pilings into the dense upper fills. After that was done we would elevate the buildings to level on the pilings and leave access to the leveling devices to readjust the building , if necessary, over the years. That plan had the added benefit of allowing global settlement of the fill layers along with all of the

HELICAL PULLDOWN™ Micropiles were selected as much piling was done between buildings only 5- 6 ' apart or on the interior of the buildings finished main floor. This allowed handheld piling equipment capable of reliably placing 40 kip (180kN) minipilings into the dense fill layers. The other advantage was the ease in constructing a small reusable leveling apparatus that could be accessed again should any portion of the structure undergo any further differential settlement. The jacking pits only, 4"x 6" square, were allowed by the central structural 1½ inch square shaft of the helical pile to transfer 40 kip (180kN) to the pile shaft embedded into the dense fill layers beneath the building. This allows safe leveling of structures with up to 13" of differential movement in the foundations and frame.

Pile configuration was 6-8-10 SS150 square shaft lead with a 4 inch fibre reinforced silica fume grout column approximately 8-10' deep. All pilings were placed to torques in excess of 4000 ft lbs.

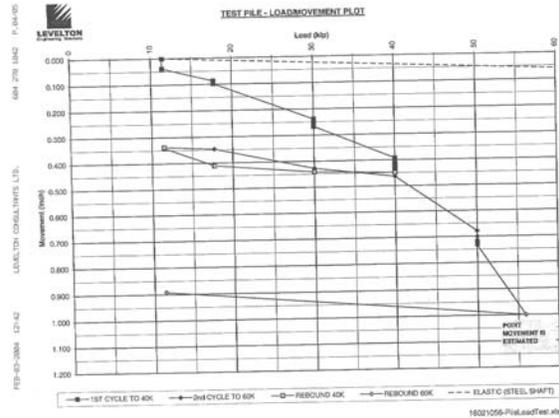
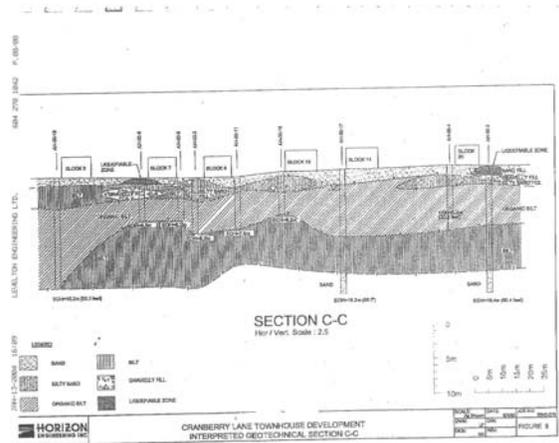
All production piling was installed using the same procedures as employed for the test piles. The grout mixture was a proprietary silica fume grout produced by Basilite Concrete Products Inc., known as Pulldown pile grout type A, reinforced with Polyfibre at a mix rate of a one pound bag for every cubic yard of grout.
