CASE STUDY

Project: Ebco Industries Galvanizing Kettle Richmond, B.C.	Geotechnical Engineer: Levelton & Assoc., Richmond, B.C.	Structural Engineer: Bogdonov Pao & Assoc., Vancouver, B.C.	Contractor: Vickars Construction Burnaby, B.C.
--	---	---	---

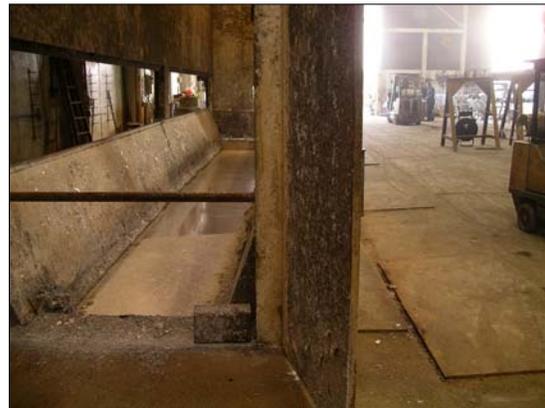
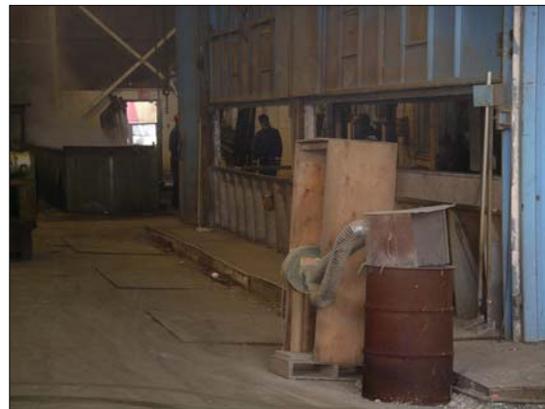
Six 4' square holes were hand excavated, 3 on either side of the long axis of the tank approximately equidistant into the bases of these excavations was a pair of helical PULLDOWN™ Micropiles employing an 8-10-12 triple helix lead

with a 6" grout column placed through a 6" diameter 10' long PVC sleeve which was pulled down with the lead and the piles subsequently placed through the PVC sleeve. The pile was placed under the direction and auspices of Levelton & Associates geotechnical engineers and the torques for placement of the piling and the grout takes for each of the piles were given to the engineer of record for certification of the piling and adequacy of capacity.

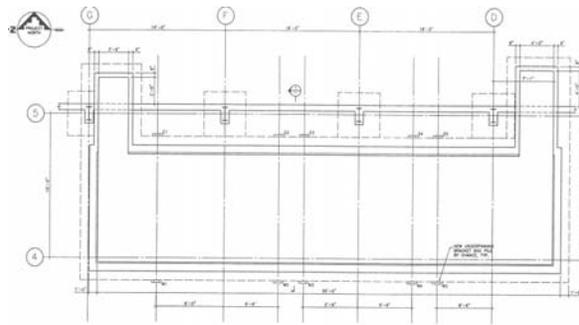
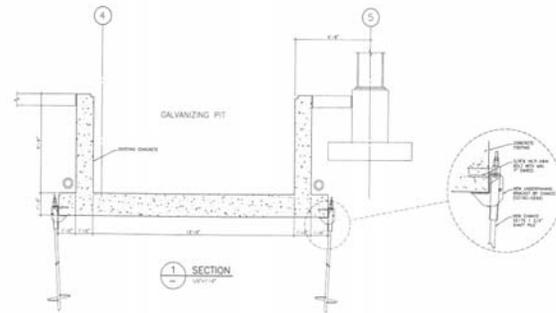
Once this was completed the underpinning bracket assemblies were attached to the perimeter foundation of the tank in the usual way and they were loaded and locked off at 20,000 lbs overall load. The tank itself was carefully measured and monitored for the ensuing 1 ½ years to 2 and it has been no appreciable movement in the tank that is measurable since the institution of the underpinning. Once the underpinning repair was completed the holes were simply backfilled to grade and the grade slab surrounding the tank was repoured in its entirety making that good.
