## A CASE HISTORY

**Project:**  
Rembrandt Terrace  
Dallas, TX

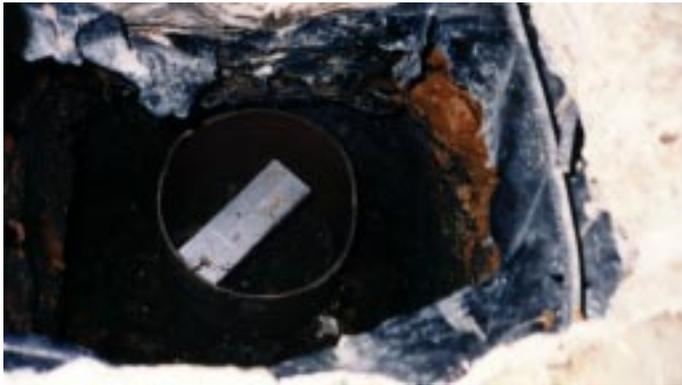
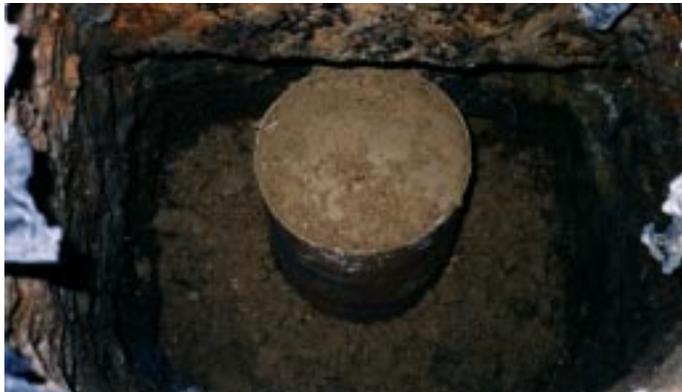
This home is a three-story brick with approximate loads expected in excess of 3000 lb. per linear ft. This home was constructed on a creek bank in North Dallas. The lay of the land was such that water drained toward the creek and under and around the home. A French drain was installed to assist in water removal, but the home had experienced both settlement and upheaval causing extensive damage to the structure.

It was decided to use the Chance HELICAL PIER<sup>®</sup> Foundation Systems anchors on the interior grade beam. A 10" helix on a 7' shaft was installed using extension material to a depth of 20' to attain a bearing capacity of 25 Kips. The shaft of the anchor would then be encased by a sonotube with a foot-bracket encased in high strength concrete. This would provide the lift platform to use to raise the interior of the home in conjunction with the lift on the exterior grade beam. The lift was effected to 9" as indicated in the bottom photo.

A class "c" fly ash slurry was pressure injected to consolidate loose soil and to fill voids between the bottom of the slab and the soil beneath that was created by the lifting process.
