# UNDERPINNING ANCHORING REPORT

## A CASE HISTORY

**Project:** Elevated Residence  
Mandeville, LA

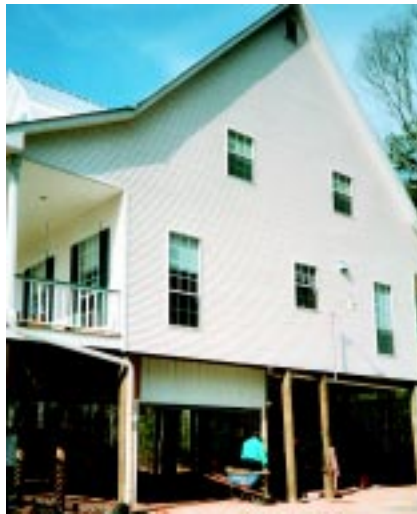
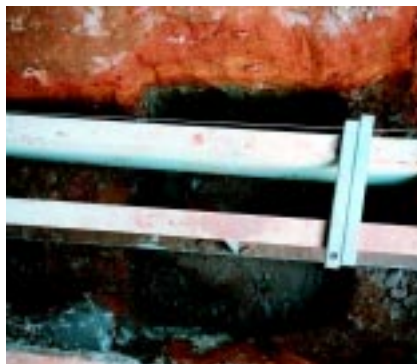
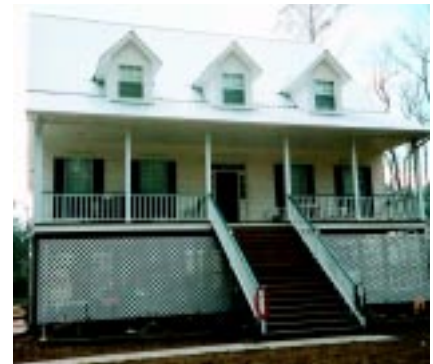
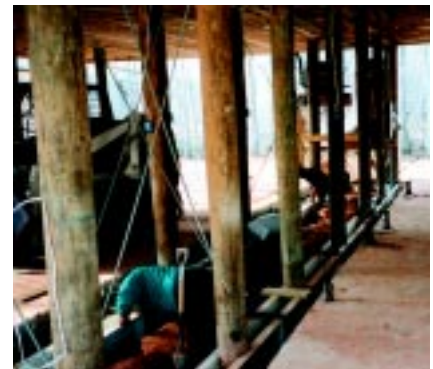
A 3-ft.-wide trench was excavated along each row of timber pilings. The timber pilings were notched at approximately 2 ft. below grade to accept two channels (C12 x 20). Notches were placed in the timber pilings so that after the lift, the channels would be level with the upper floor. The 45-ft.-long continuous channels were bolted to each timber pile with three 7/8-inch throughbolts.

Chance HELICAL PIER<sup>®</sup> Foundation Systems anchors were installed between the timber pilings. Each anchor had a 1½-inch square round-cornered steel shaft with four helices of 10, 12, 14 and 14-inch diameters. The installation unit was a Bobcat 853H equipped with a 12,500 ft.-lb. Eskridge drive motor and an ESI DP1 in-line torque indicator. Installed depths of the anchors varied from 20 to 30 ft. along the pile row farther from the river

and from 50 to 55 ft. along the pile row closer to the river. All anchors were installed to 5,300 ft.-lb. of torque.

A pile cap area was excavated at a depth of 20 inches below the bottom of the continuous channels. The pile cap consisted of a reinforced channel assembly with a pipe sleeve for connection to each anchor. This assembly

Two hydraulic jacks were symmetrically positioned on either side of the anchors. The lift load consisted of two parts: The structure's dead load with furnishings plus the adhesion forces along the timber pilings. The structure was releveled to within a ¼-in. tolerance. The maximum lift was 5½ in. on the center two rows of timber piling.
