# UNDERPINNING ANCHORING REPORT

## A CASE HISTORY

**Project:** Wall Repair,  
Peterson Farms

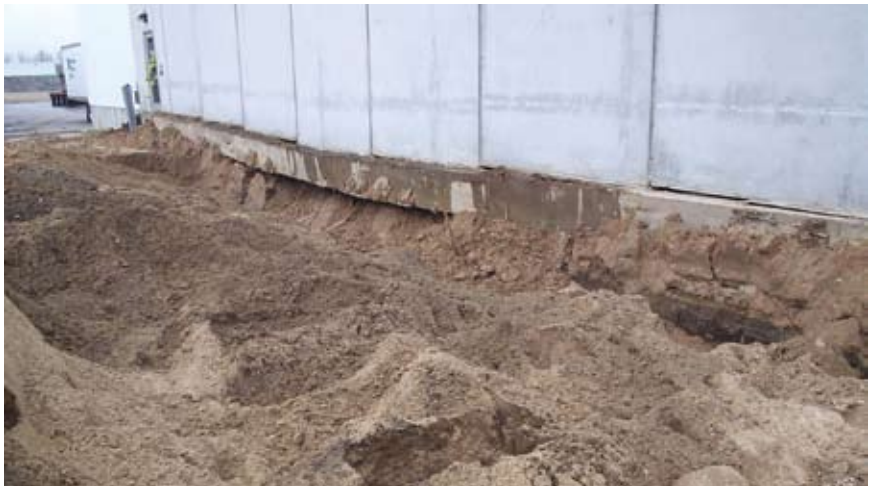
Regrading along a 200 ft. side of a tilt-up-wall building resulted in undercutting the grade beam by as much as 2 ft. In less than one day, the grade beam, wall, and roof dropped in places as much as 14" and slid out horizontally as much as 6".

Above, building condition upon arrival at the jobsite

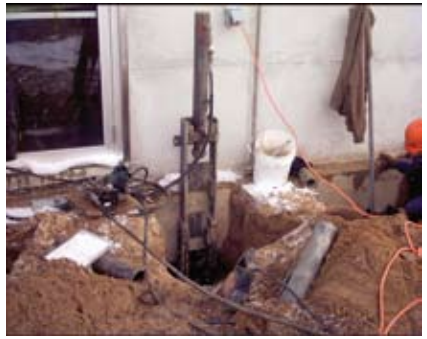
- 1. Above, excavating to set piers
- 2. Below, lifting grade beam and wall with hydraulic jacks

It provided for installing 39 Atlas Resistance® piers on 5-ft. centers along the entire 200-ft. wall. Each pier was sleeved and grouted to maximize pier shaft stiffness.

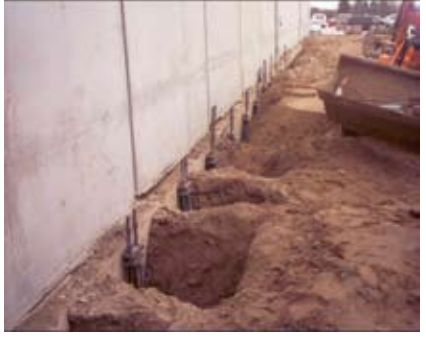
Torealign beam, 38 CHANCE® helical tieback anchors were installed between Atlas Resistance® piers.

With wall elevation restored and beam straightened, pier holes were filled to final grade.
