## A CASE HISTORY

Pineland Baptist Church  
Burlington, Ontario

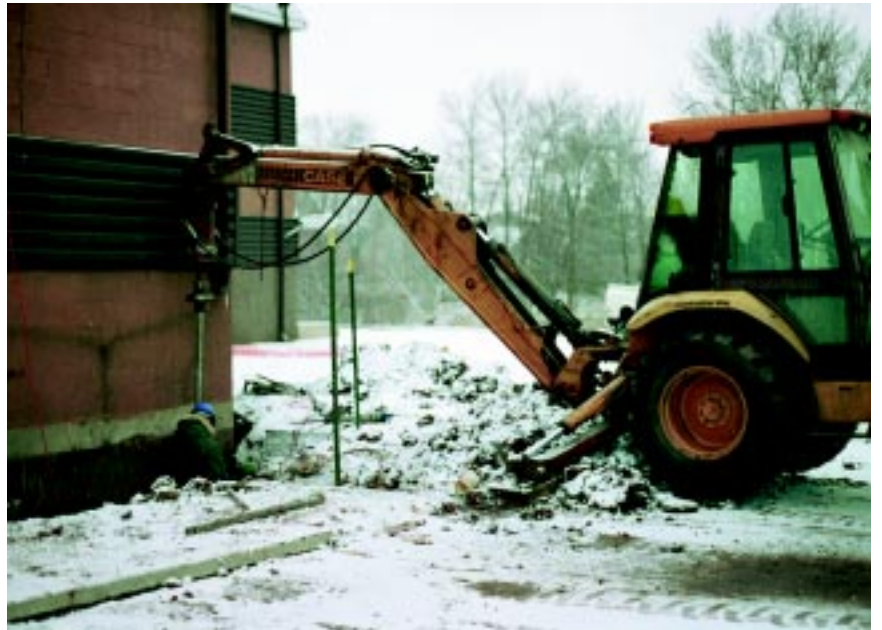
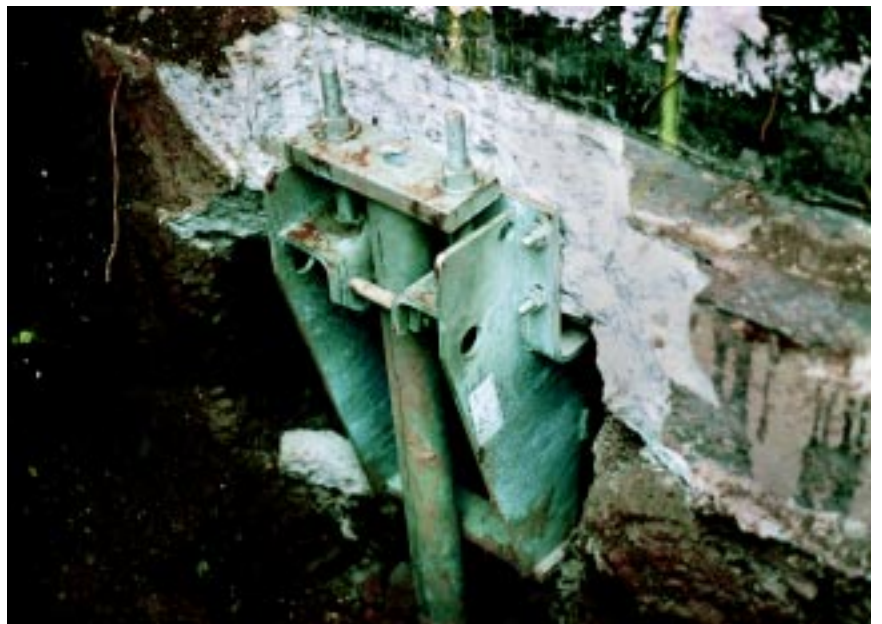
A spread footing located in the clayey silt fill had not provided an adequate foundation for the addition. Significant cracking was evident in the brick facing on the southeast corner of the addition. Vertical cracks in the original structure were determined to be the result of the addition settling and rotating out, away from the rest of the structure.

Seven two-helix SS175 anchors were used to underpin the settling addition. The maximum design load per anchor was 30.25 kip. Installation torque of 9,000 to 10,000 ft.-lb. was enough to penetrate the shale. The anchors were loaded until a positive displacement ( $1/8$ " approx.) was seen with a transit-level. The building could have been lifted back to a level position had the brick facing not been repointed.
