A CASE HISTORY

Tohatchi High School Gym
Tohatchi, New Mexico

Job Description:

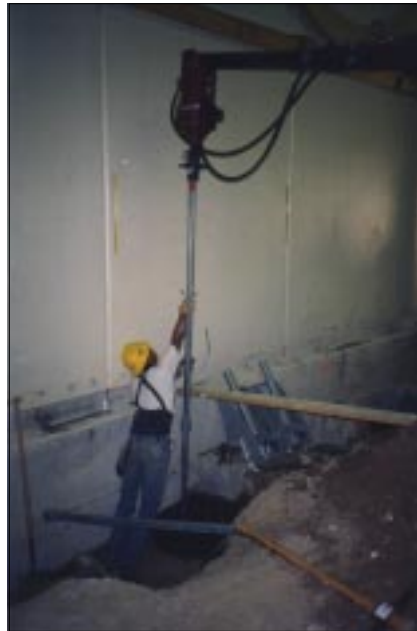
The wood gym floor and concrete slab were removed. Around the interior of the gym and the exterior of the tilt-up building, 132 anchors (each with three helices of 8-, 10- and 12-inch diameters on a 1 $\frac{3}{4}$ -inch-square shaft) were installed to depths of 13 to 24 $\frac{1}{2}$ feet on intervals of 6 to 8 feet. The anchors were installed by a 10,000 ft.-lb. hydraulic motor mounted on a skid loader.

Design load capacities of these anchors varied from 21 to 40 Kips. All piers were installed with a 2:1 safety factor to provide ultimate capacities from 42 to 80 Kips.

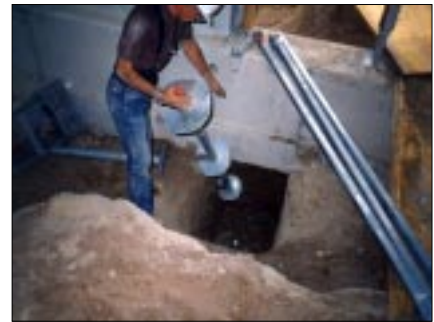
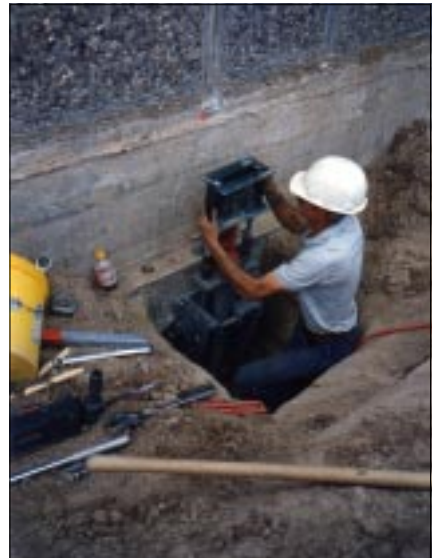
Chance Heavy-Duty underpinning brackets (40,000-lb. working capacity) connected the anchors to the foundation footing. 30-ton jacks were mounted on the brackets to lift the foundation in intermediate steps back to level.

The adjoining locker rooms were supported by 120 Chance screw anchors (each with an 8-inch-diameter helix on a 1 $\frac{1}{2}$ -inch-square shaft) and slab brackets on 6-ft. grids. These slab anchors were installed through 8-inch

holes cored through the slab to average depths of 20 feet for the 6 Kips design load. The anchors were installed by a custom-made 5,000 ft.-lb. portable drive rig bolted to the slab

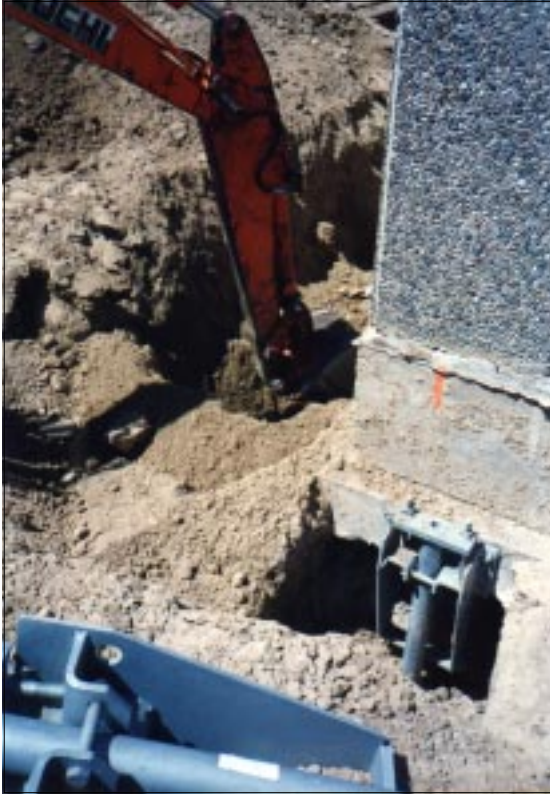
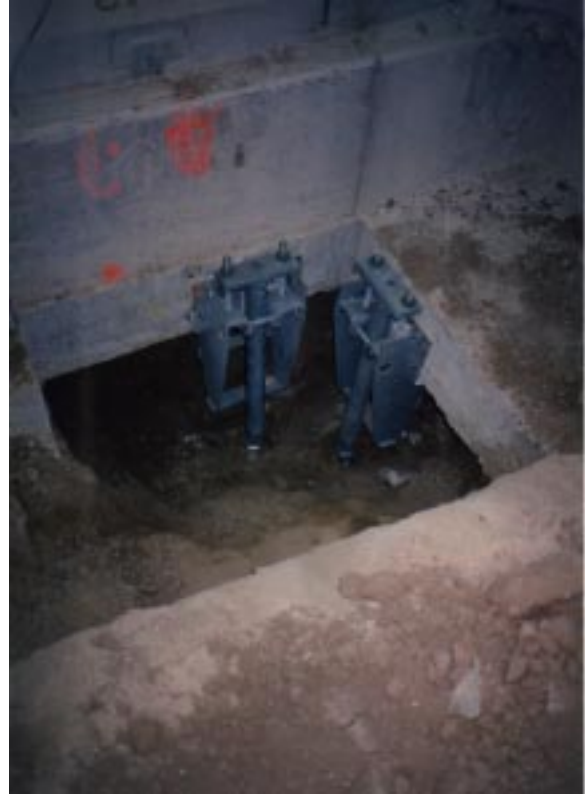
Heavy-Duty underpinning brackets installed outside and inside perimeter of foundation.

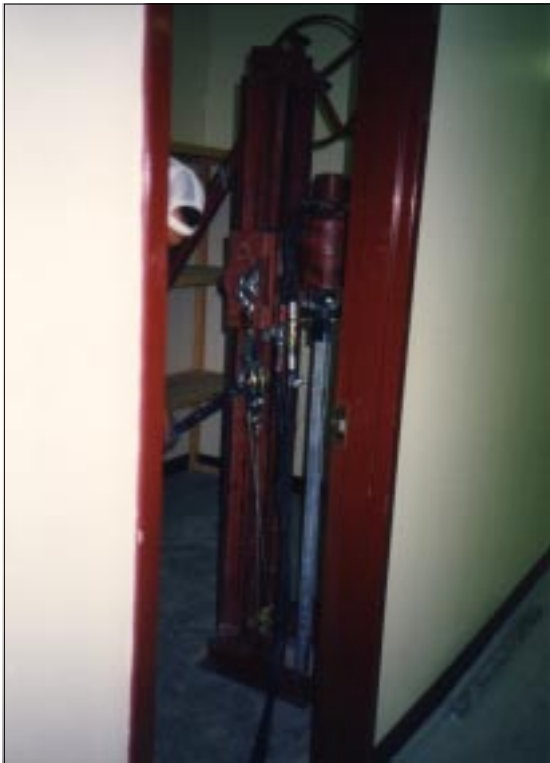
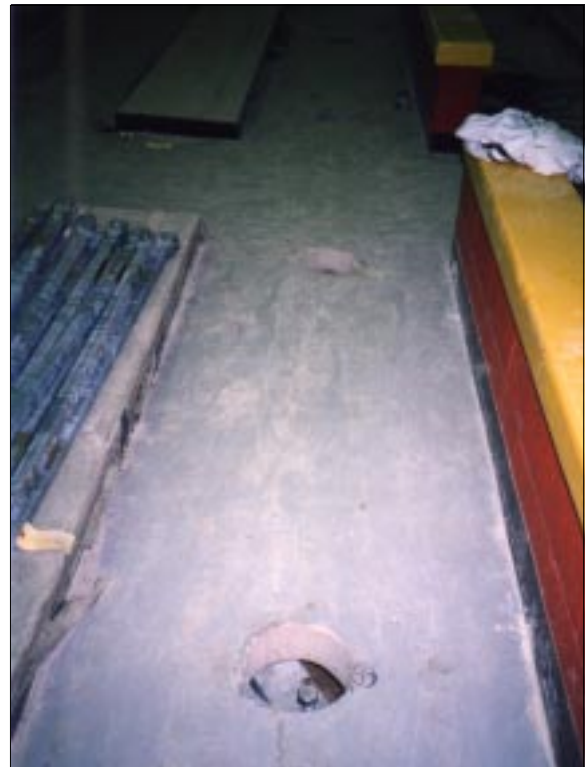
Slab-leveling anchor being installed and bracket bolt visible through core which was refilled after final adjustment.

at each location. To lift the slab back to level, approximately 150 ft.-lb. of torque was applied to the slab-brackets' lifting bolts.
