CHANCE[®] UNDERPINNING ANCHORING REPORT

A CASE HISTORY

Engineering Building East,
University of Missouri
Columbia, MO

Bulletin 01-9808

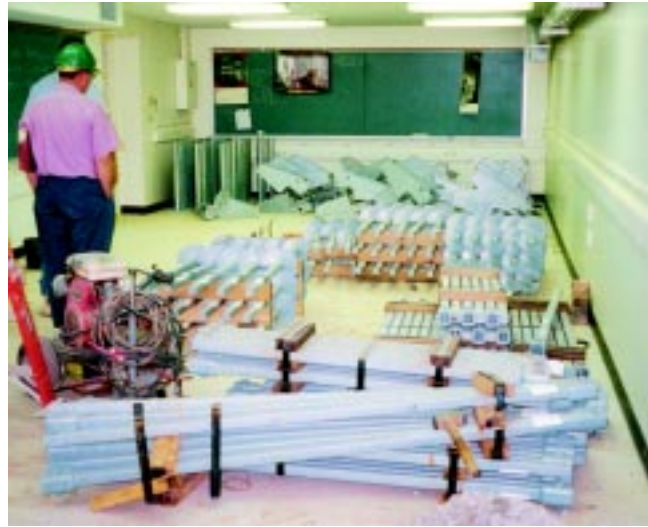
The anchors would be located both outside and inside the building, staggering their locations to minimize the rotational forces. Spacing between the centerline of the anchors was to be 4 feet except at the bell tower where they would be spaced 2 to 3 feet apart.

The owners' project manager was Eric Peterson of the University of Missouri and the engineer of record was Ralph Jones of Structural Engineering Association, Inc. of Kansas City, Missouri. Engineering Surveys & Services of Columbia, Missouri did the soil surveys of the site. The foundation-deepening method selected was the Chance high strength steel SS175 HELICAL PIER® Foundation Systems anchor. The 1¾"-square shaft twin-helix lead sections with extensions were to be driven to 10,000 ft.-lb. of torque and terminated with the Chance heavy-duty bracket. Once fastened in place, the bracket would be encased in a 2 x 2 x 3½ feet concrete block cast in place.

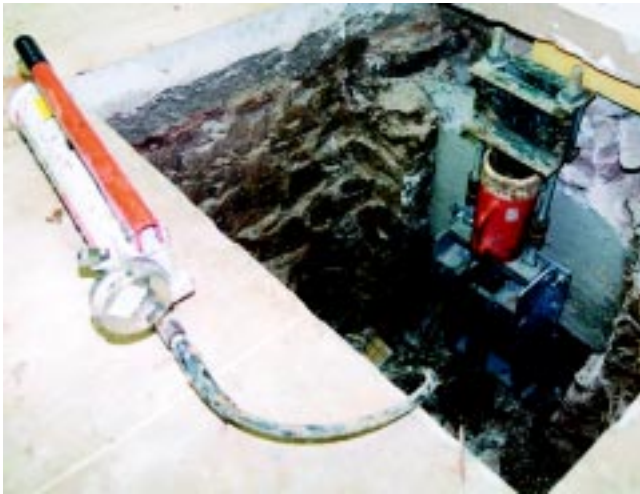
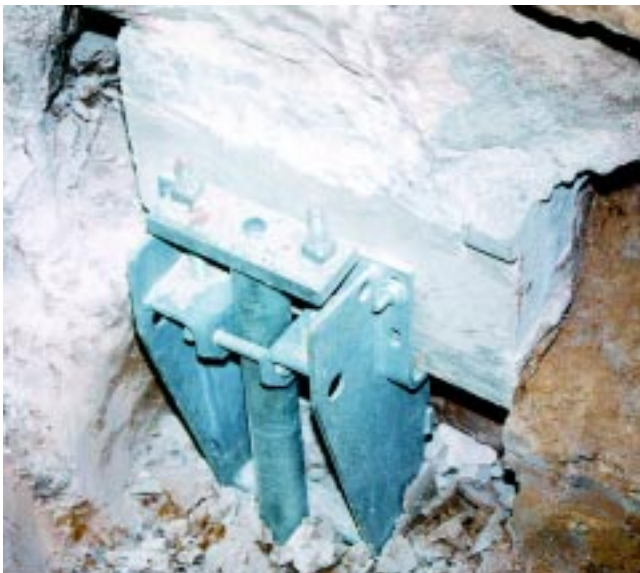
The skidloader was used for installation of the outside perimeter anchors while the hand-held unit was used inside the building. During construction, several unexpected non-representative areas were encountered requiring foundation upgrade for anchor attachment. The engineer and contractor were able to adjust the construction and the project finished well ahead of the projected schedule. HELICAL PIER® Foundation Systems can be adjusted to site conditions by adding extensions or adding helices to meet the load requirements in different bearing soils. The foundation anchor bracket requires a competent foundation for attachment and to transfer the load to the anchor. This required a concrete block to be cast in place upgrading the foundation for the anchor to attach properly. Once the attachment blocks were cast, the installation of the foundation anchors proceeded rapidly.
